American Pride Home Inspection LLC

Confidential - Property Inspection Report - Confidential

200 My Street, Any Town, OK 73068
Inspection prepared for: Sample Report
Date of Inspection: 5/15/2012
Age of Home: 50 Years

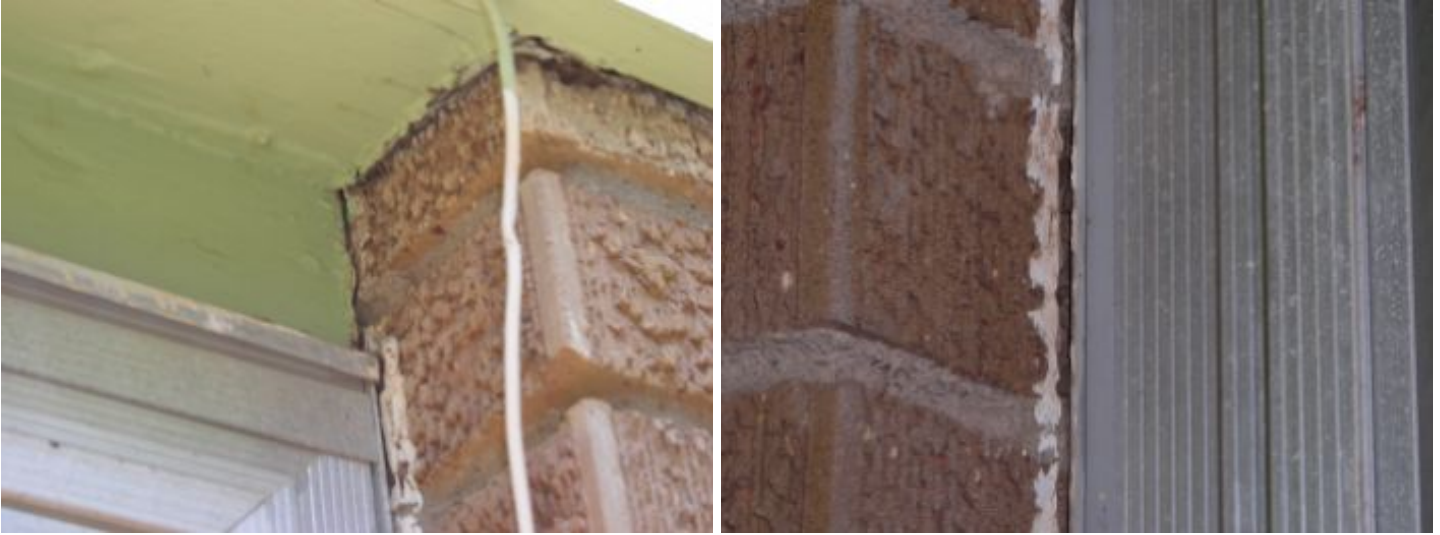
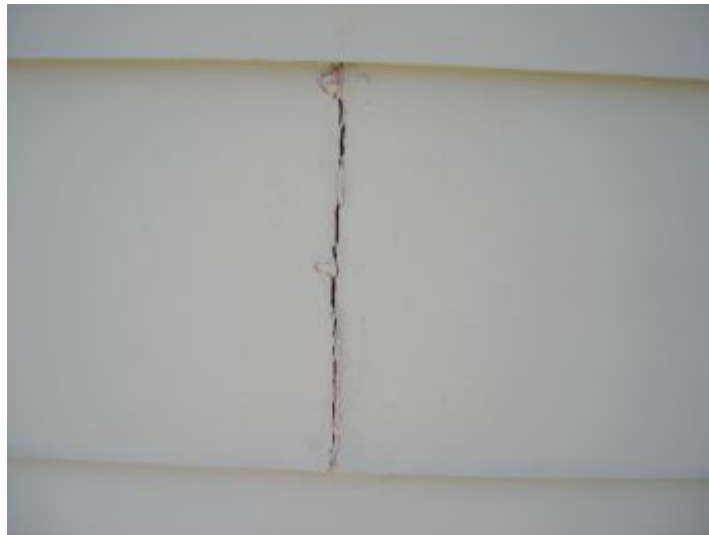
10. Exterior Caulking

- Caulking loose/missing/cracked/broken around all exterior windows.

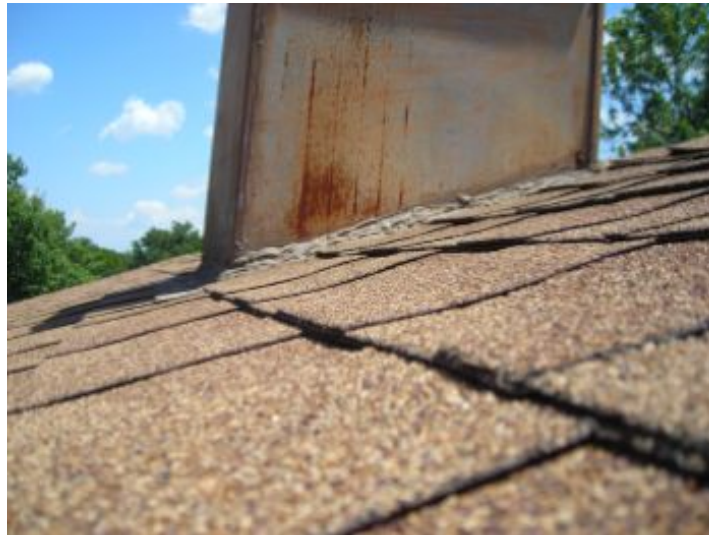
6. Chimney(s)

- Observed from garage roof. Flashing repairs have been made with silicone caulk. Advise having a roofing specialist evaluate.

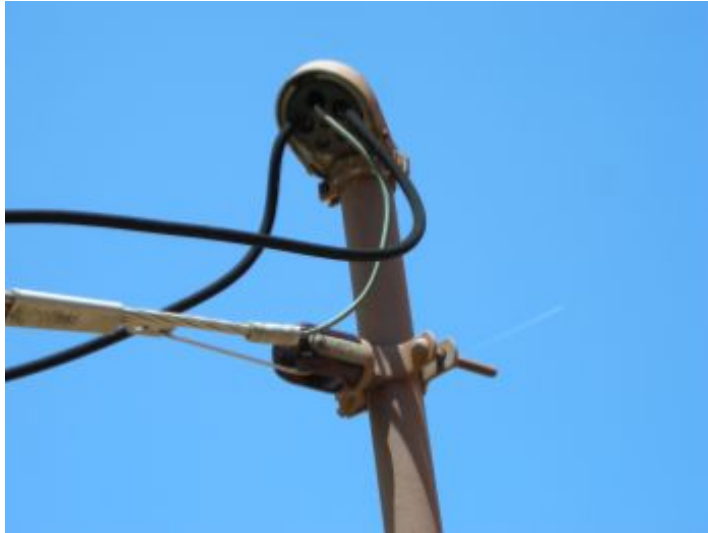
1. Service Drop

- Wires are sagging, recommend review by the local utility company for repair as necessary.

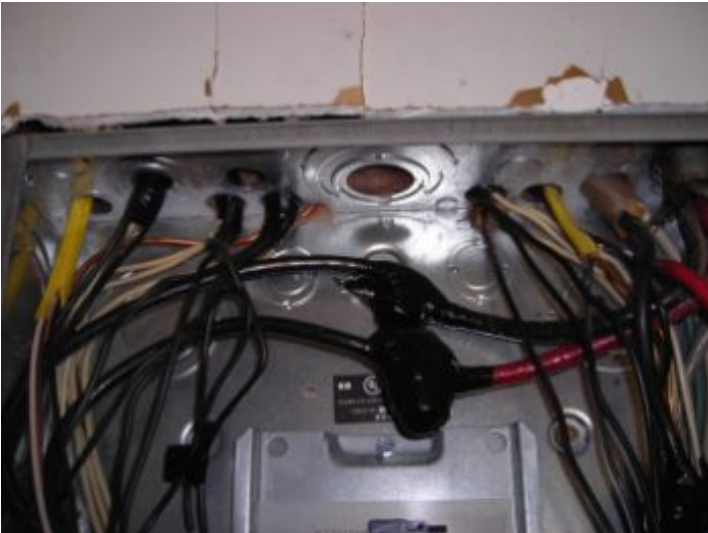
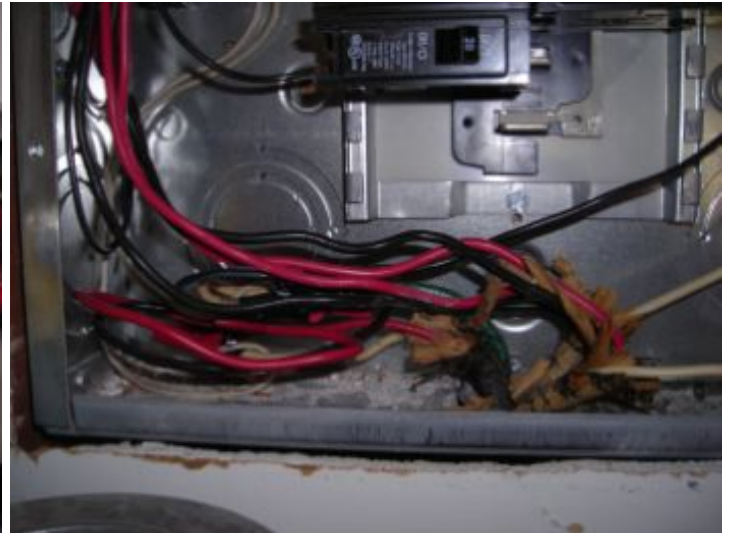
4. Main Service Panel(s)

- Improper connection of a ground wire. No clamps on wires entering the panel.

- Recommend a qualified electrician examine panel.
