# **American Pride Home Inspection LLC**

**Confidential - Property Inspection Report - Confidential**

100 Any Place, Norman, OK 73071  
Inspection prepared for: Some Body  
Real Estate Agent: Support - Home Inspector Pro

Date of Inspection: 12/12/2012

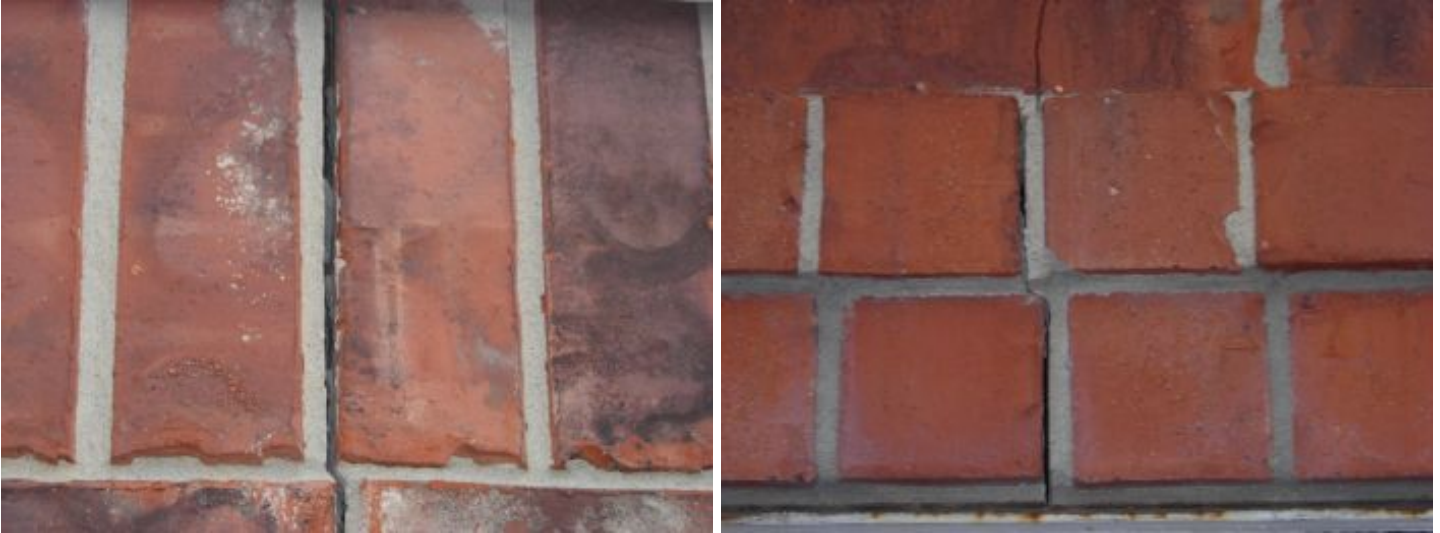
- The house siding appeared in serviceable condition, at time of inspection.
- Brick has several vertical cracks above garage door. Recommend sealing to prevent further cracking.

<i>Exterior</i>		
Page 5 Item: 5	Exterior Cladding	<ul style="list-style-type: none"> <li>• Brick has several vertical cracks above garage door. Recommend sealing to prevent further cracking.</li> </ul>
Page 5 Item: 7	Window/Door Frames and Trim	<ul style="list-style-type: none"> <li>• Weathered wood surfaces observed at the two upper windows on the north side of home. Wood deterioration and rot . Recommend repair.</li> </ul>
Page 6 Item: 8	Exterior Caulking	<ul style="list-style-type: none"> <li>• Caulking loose/missing/cracked/broken around garage door trim. Recommend repair.</li> <li>• Some areas where caulk is cracking. Recommend repair as needed.</li> </ul>
<i>Attic and Insulation</i>		
Page 10 Item: 4	Attic Ventilation	<ul style="list-style-type: none"> <li>• Some of the under eave attic vents are dirty and should be cleaned to provide adequate ventilation.</li> </ul>
<i>Interior</i>		
Page 11 Item: 4	Windows	<ul style="list-style-type: none"> <li>• Cracked or broken window glass was observed in the up stairs front bedroom. Recommend repair or replacement of the damaged glass.</li> <li>• Two torn screen in the living room, back of home. Recommend repair.</li> </ul>

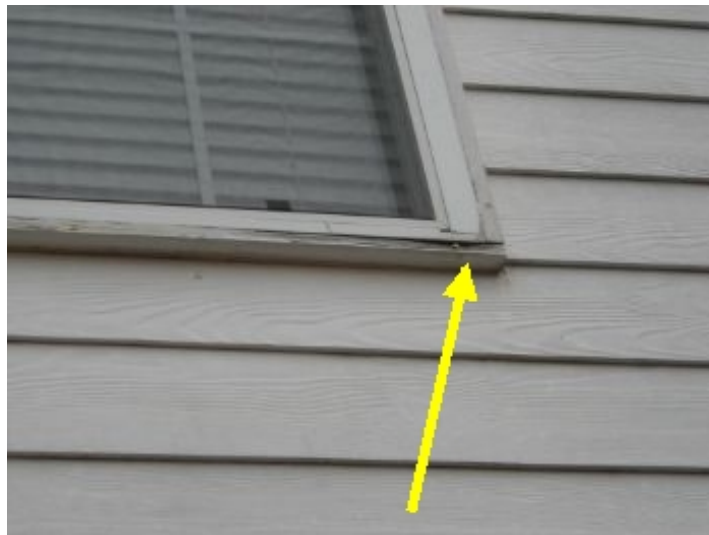
Rotting window trim

- Components appeared in satisfactory condition at time of inspection.
- Weathered wood surfaces observed at the two upper windows on the north side of home. Wood deterioration and rot . Recommend repair.

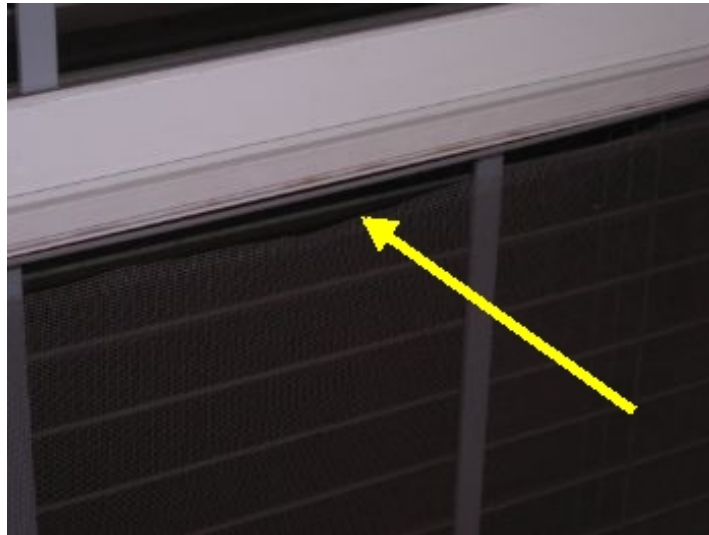
Torn screen

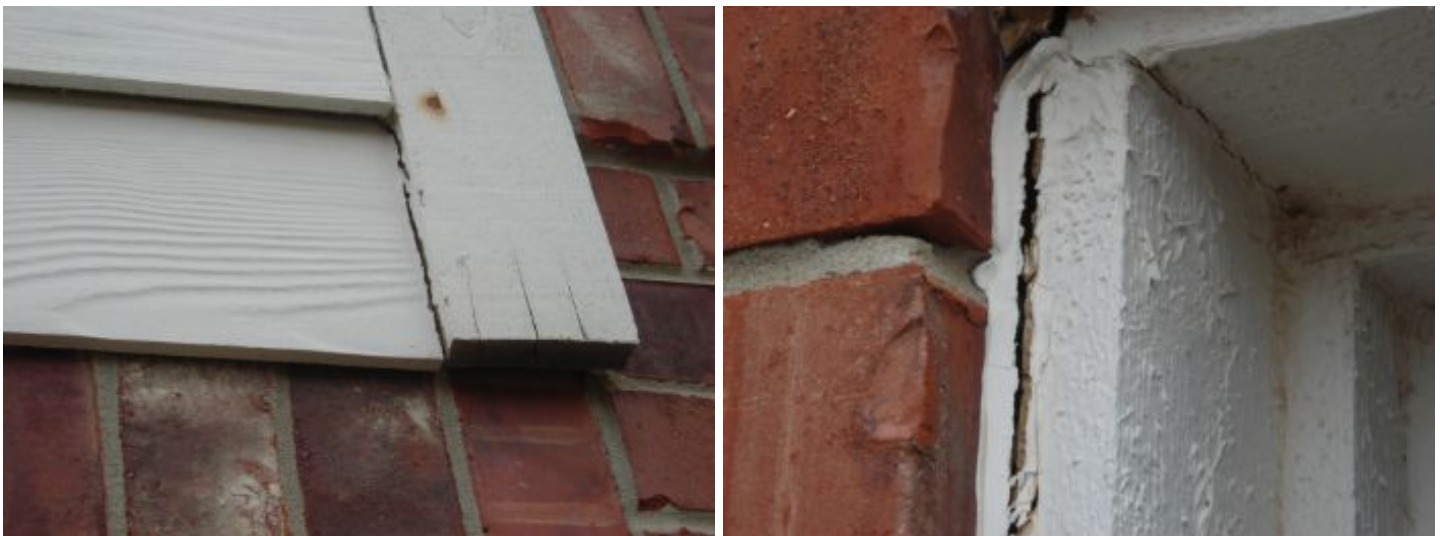
- Caulking loose/missing/cracked/broken around garage door trim. Recommend repair.
- Some areas where caulk is cracking. Recommend repair as needed.

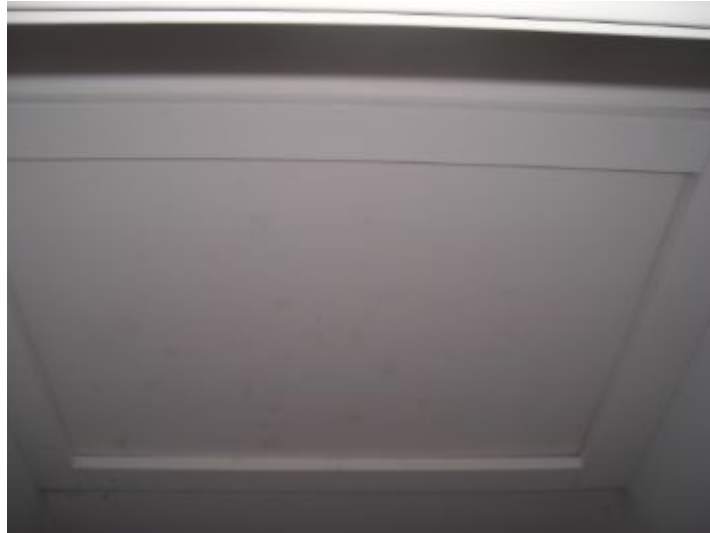
Observations: Could not access due to personal items

access in upstairs bedroom closet.

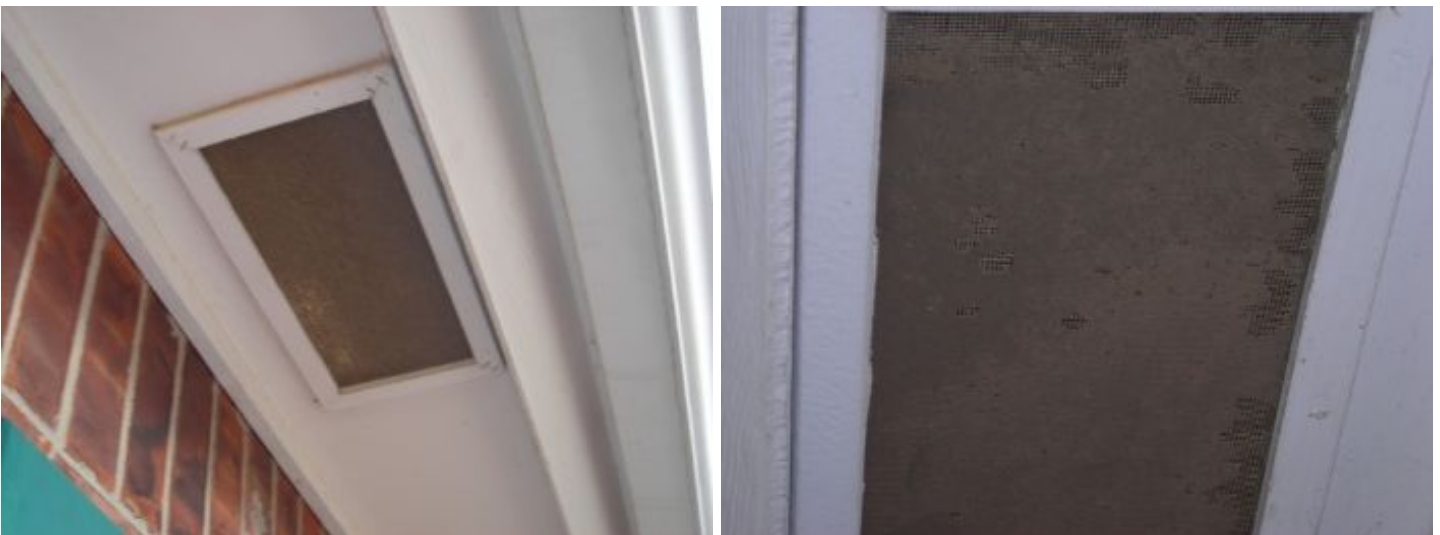
- Existing attic ventilation appears adequate.
- Some of the under eave attic vents are dirty and should be cleaned to provide adequate ventilation.

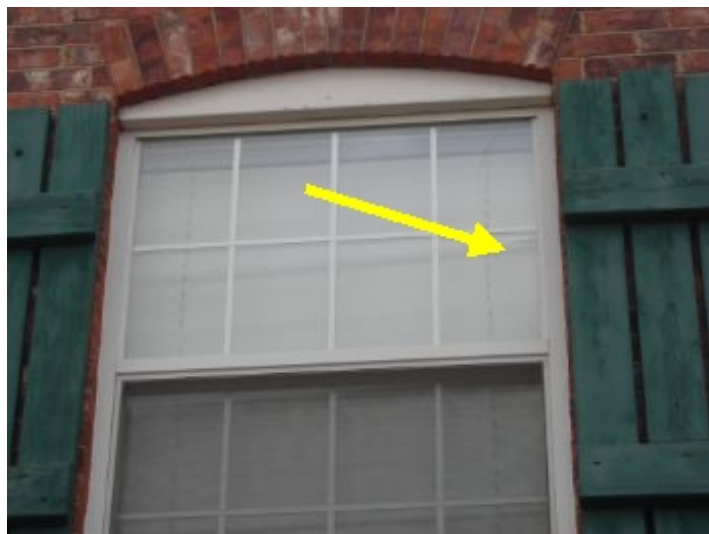
- In accordance with ASHI Standards, we do not test every window in the house, and particularly if it is furnished. We do test every unobstructed window in every bedroom to ensure that at least one provides and emergency exit.
- The windows that were tested, are functional.
- Cracked or broken window glass was observed in the up stairs front bedroom. Recommend repair or replacement of the damaged glass.
- Two torn screen in the living room, back of home. Recommend repair.

Cracked window in upstairs bedroom

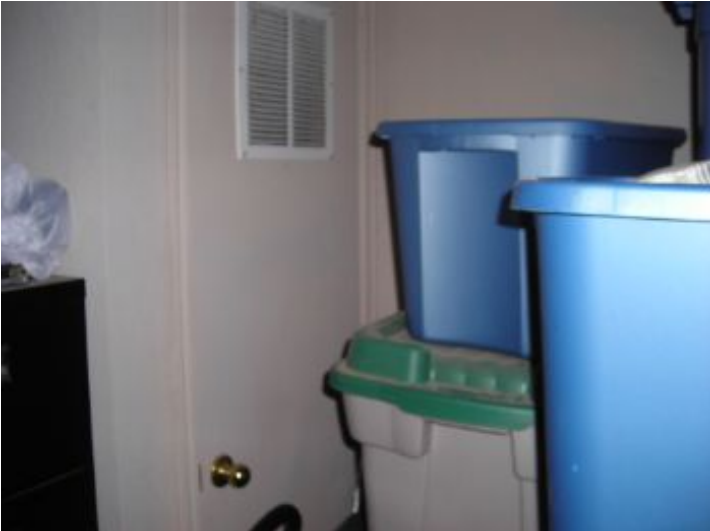
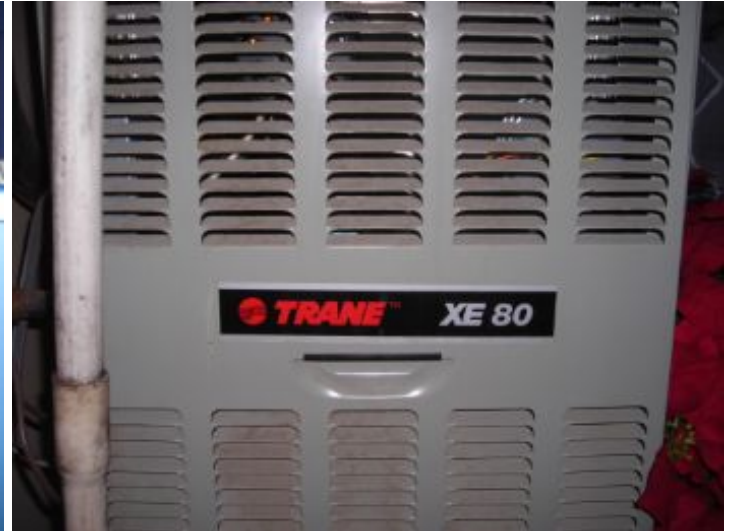
Heating system in garage blocked.

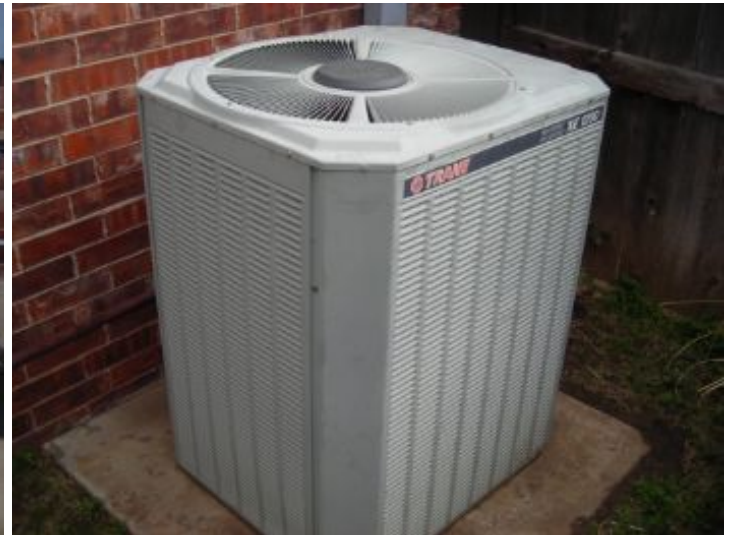
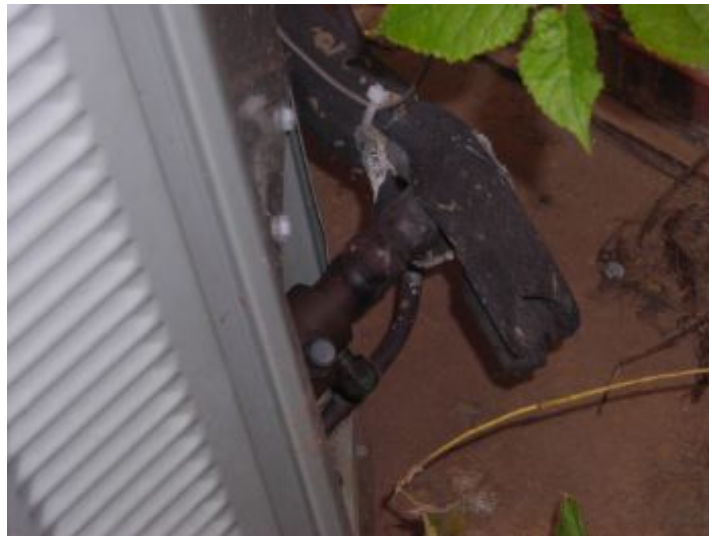
South side AC

- No deficiencies noted at the time of inspection.
- The insulation is missing or damaged at exterior refrigerant line on South side AC. Recommend repair.

<i>Heating and Air Conditioning</i>		
Page 14 Item: 7	Cooling System	<ul style="list-style-type: none"> <li>• The insulation is missing or damaged at exterior refrigerant line on South side AC. Recommend repair.</li> </ul>
Page 15 Item: 11	Filter(s)	<ul style="list-style-type: none"> <li>• Furnace filter dirty. Needs replacement</li> </ul>
<i>Bathrooms</i>		
Page 21 Item: 3	Sink(s)	<ul style="list-style-type: none"> <li>• Left side sink in the upstairs hall bath drains slowly. Recommend repair.</li> </ul>
<i>Appliances</i>		
Page 22 Item: 3	Ranges, Ovens, Cooktops	<ul style="list-style-type: none"> <li>• The burners did not operate properly when tested. Electronic ignition not functioning. Recommend repair.</li> </ul>
Page 22 Item: 9	Dryer Vent	<ul style="list-style-type: none"> <li>• Birds nest in dryer vent. Recommend cleaning of vent.</li> </ul>

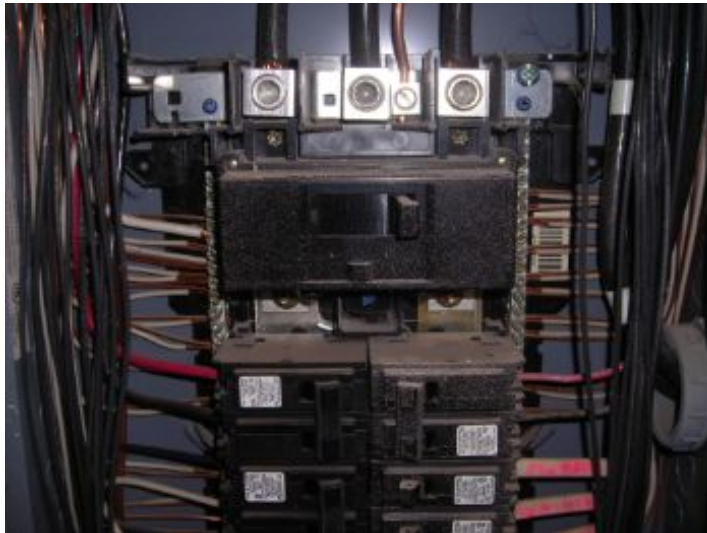
Location: On Main Panel (See Photo)

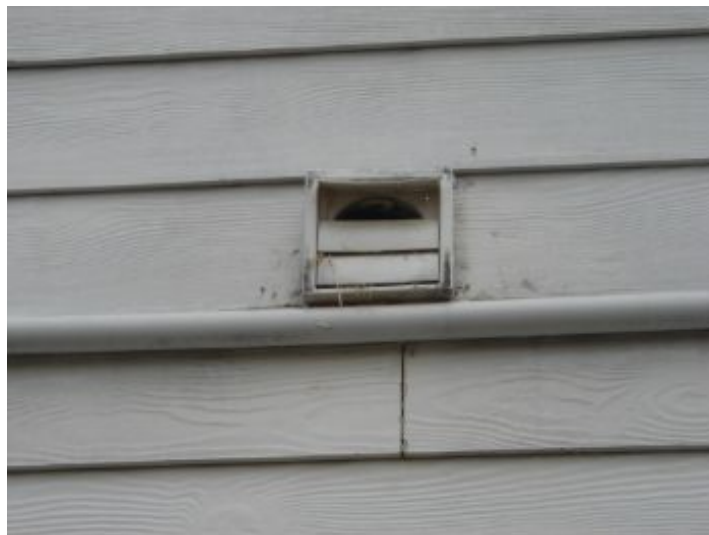
- Properly vented to exterior.
- MAINTENANCE: Annual cleaning of dryer vent duct recommended, as fire safety.
- Birds nest in dryer vent. Recommend cleaning of vent.
